~~CONFIDENTIAL~~  
**BUREAU OF SHIPS GROUP**  
**TECHNICAL INSPECTION REPORT**  
~~CONFIDENTIAL~~

**6 OPERATION CROSSROADS.**  
**U.S.S. BRULE (APA 66).**

**TEST ABLE [U].**

BUREAU OF SHIPS GROUP  
TECHNICAL INSPECTION REPORT

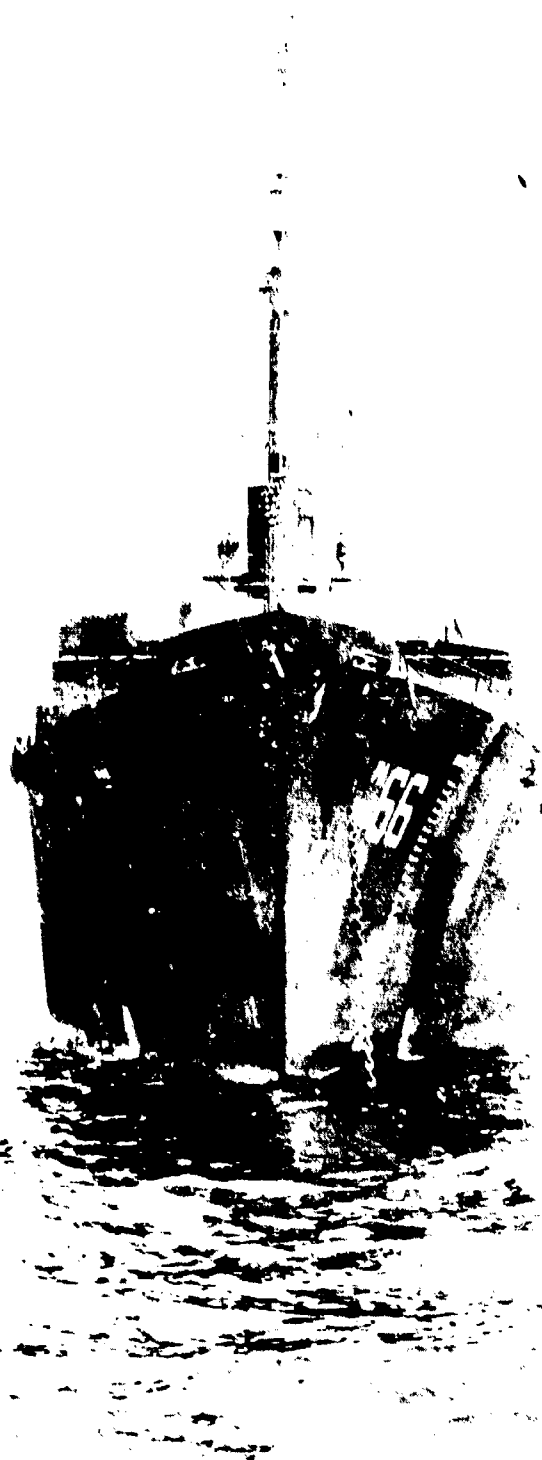
AA-CR-227-49-110. Bow after Test A.

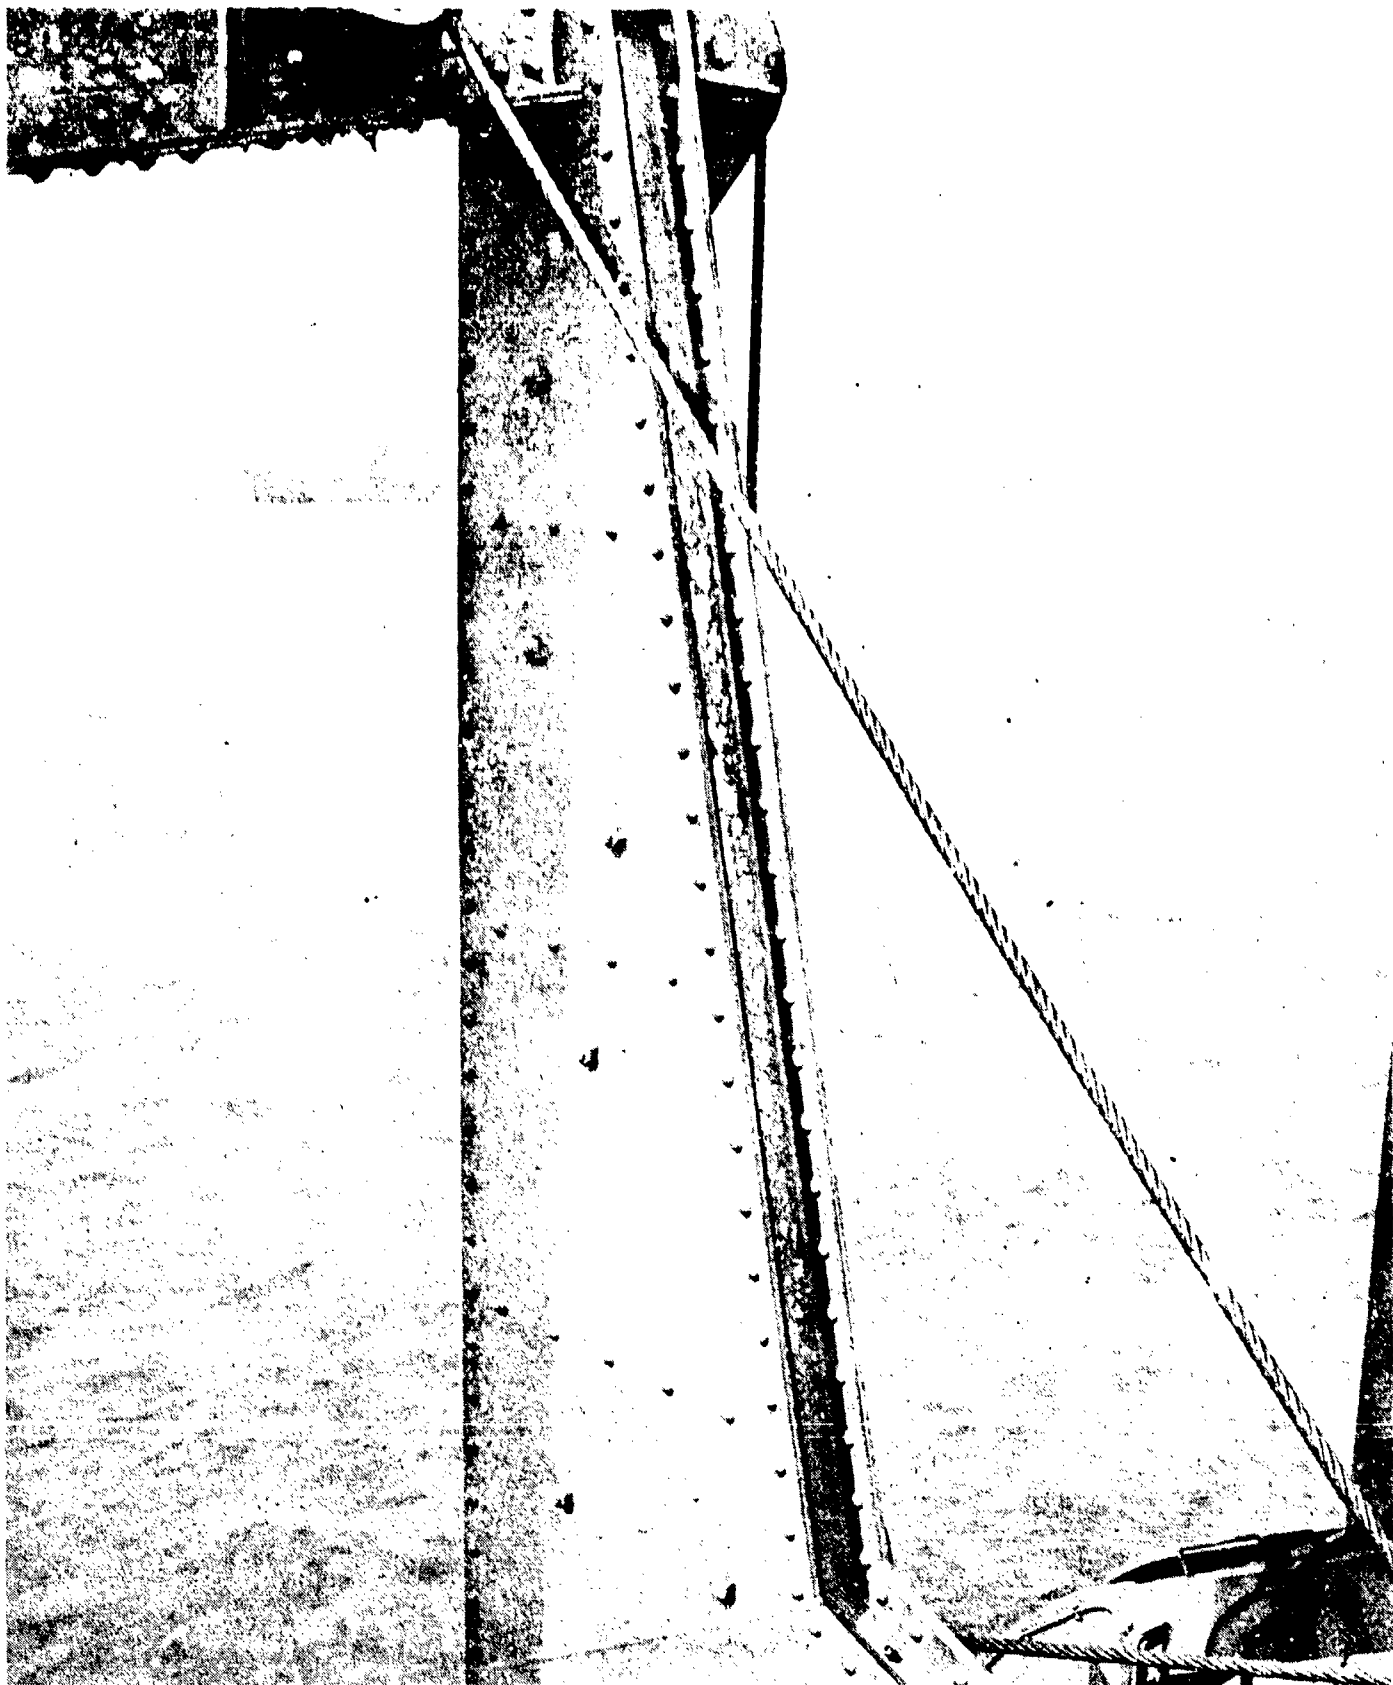
The source of radiation bore about 120 degrees relative. All surfaces facing aft or to starboard, unless shielded by structure, are blistered. Evidence of vortexing of the heat wave was seen on the starboard boat davits where blistering and scorching of paint occurred on the lee sides. Zinc chromate, formula 84, seems to be affected more than ordinary top coats similarly exposed. Wood surfaces received greater blistering than corresponding steel surfaces. Grease was not burned on cables or hoist drums. No glass was broken by heat. Scorching of all exposed fire hoses and cordage was noted. Insulation was scorched on a few electric cables on the starboard side aft.

AA-CR-65-1819-9. Scorched paint on forward side of after leg of Welin davit on starboard side.

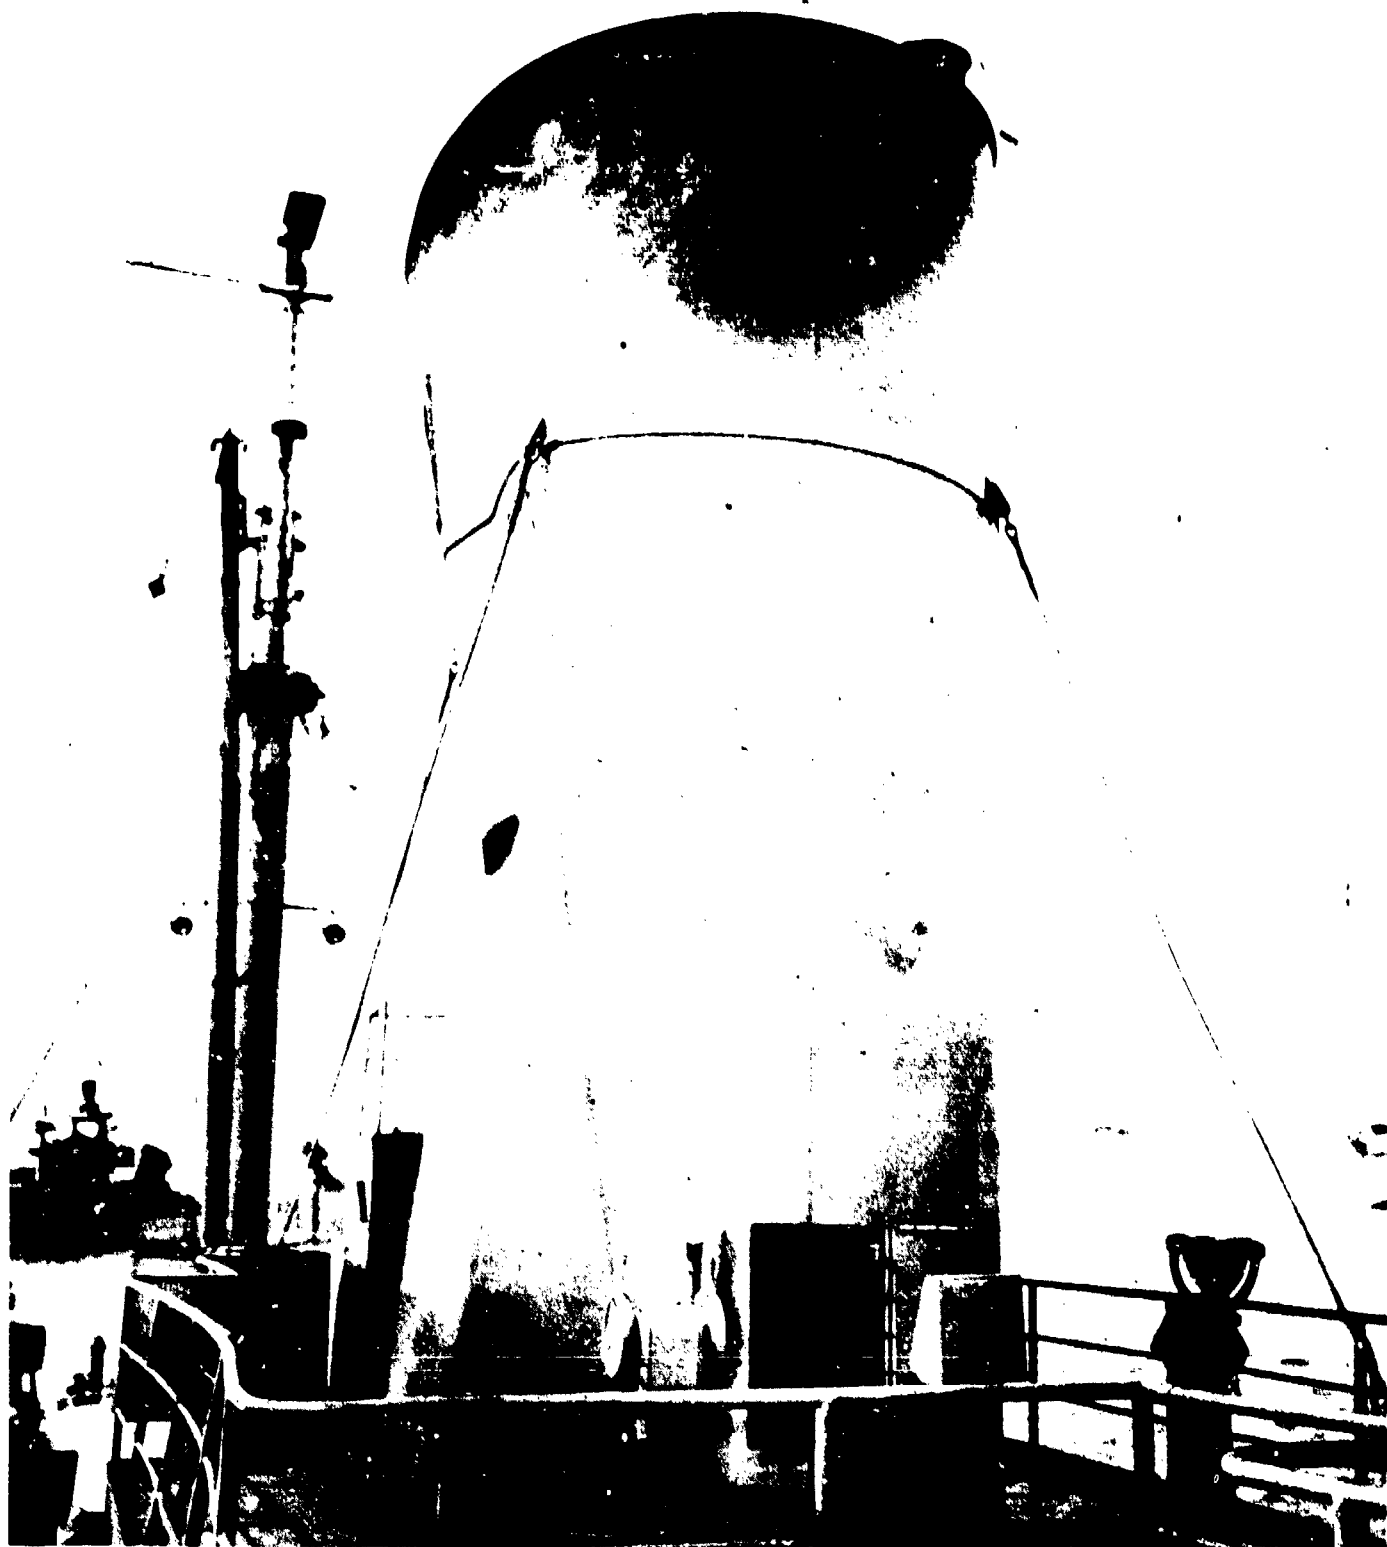
AA-CR-62-2172-9. Looking aft at damage to after stack. Note pedestal of missing magnetic compass in foreground.

Magnetic compass binnacles should be redesigned to be less susceptible to blast damage and to have more rugged gimble rings.

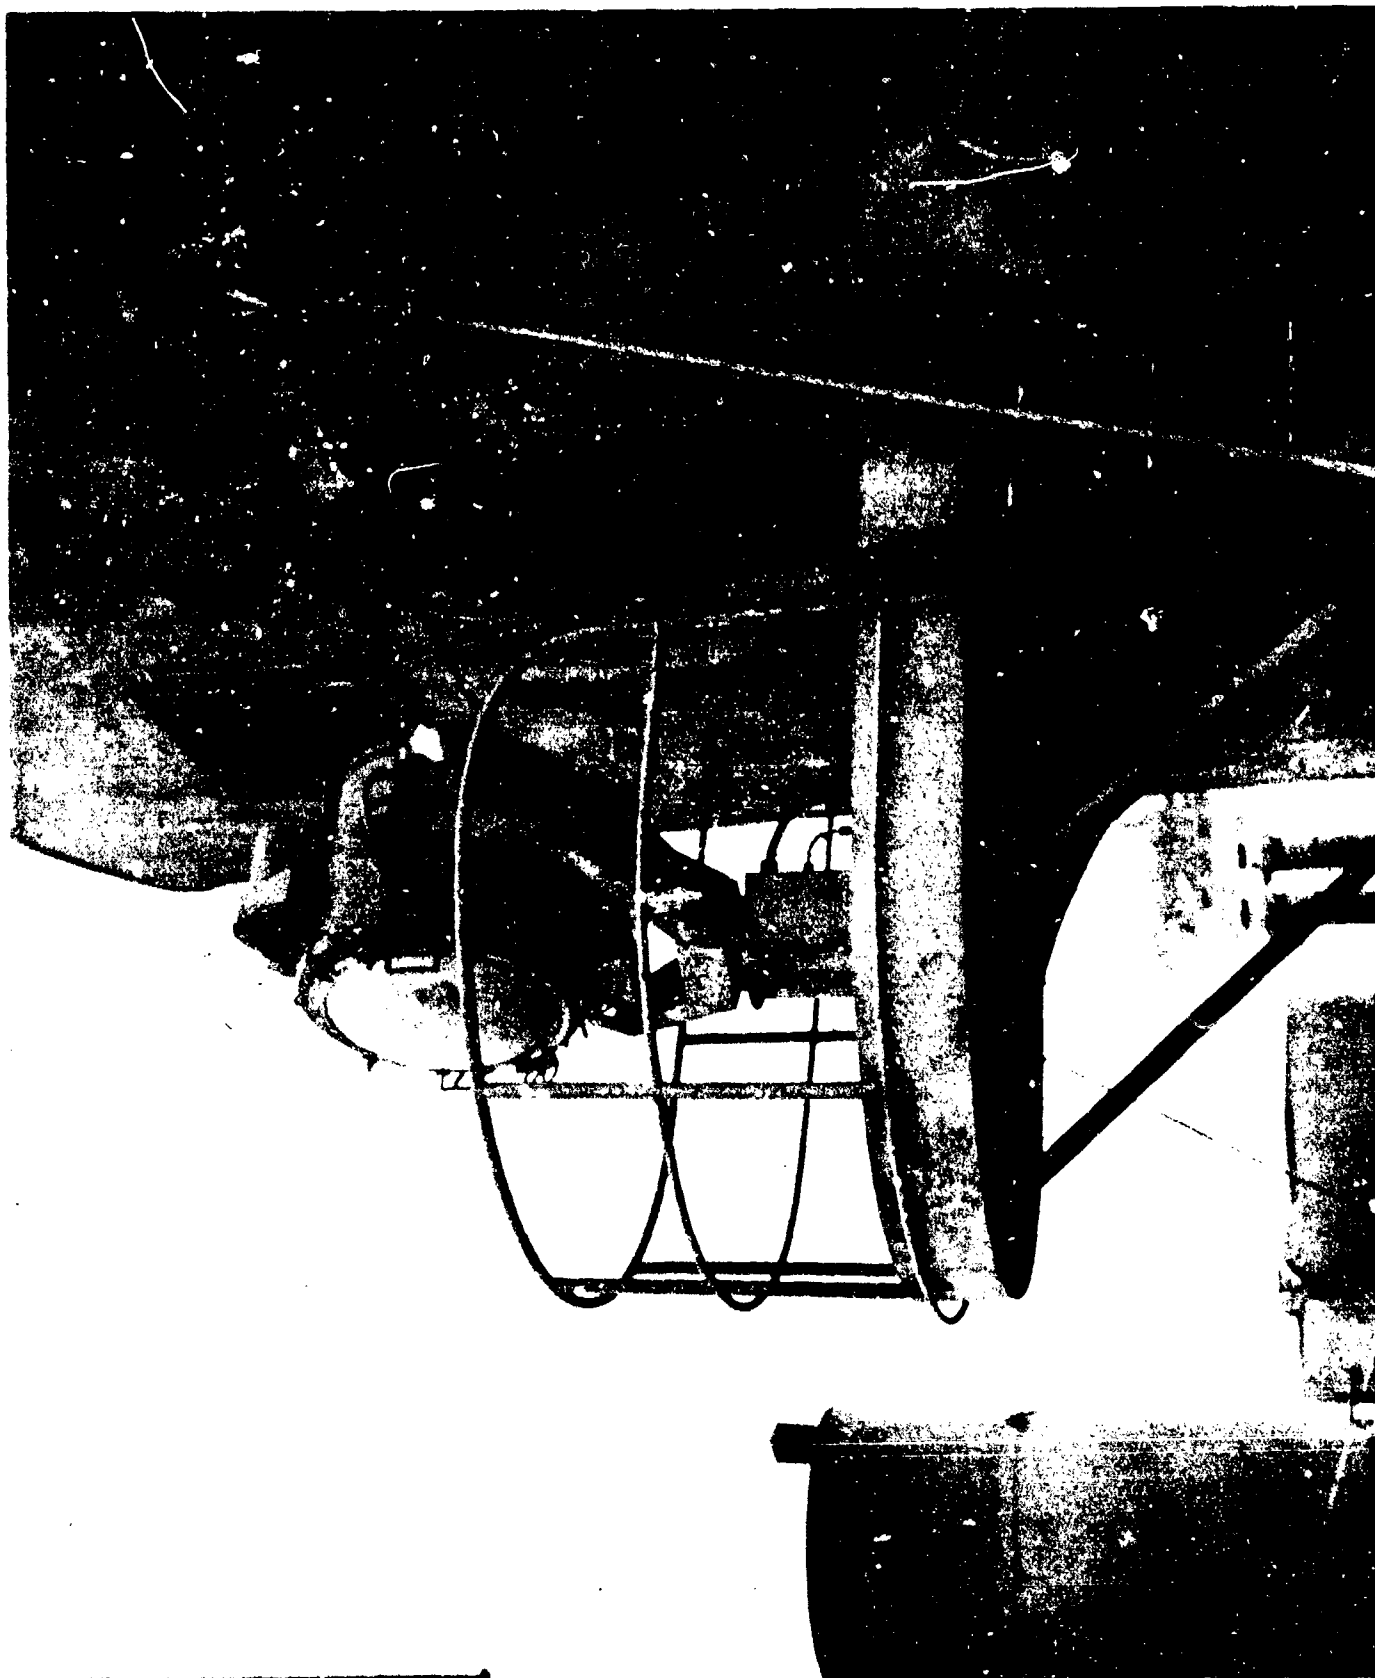
AA-CR-175-2157-2. Bent king-pin of 24 inch searchlight on starboard side of forward stack.

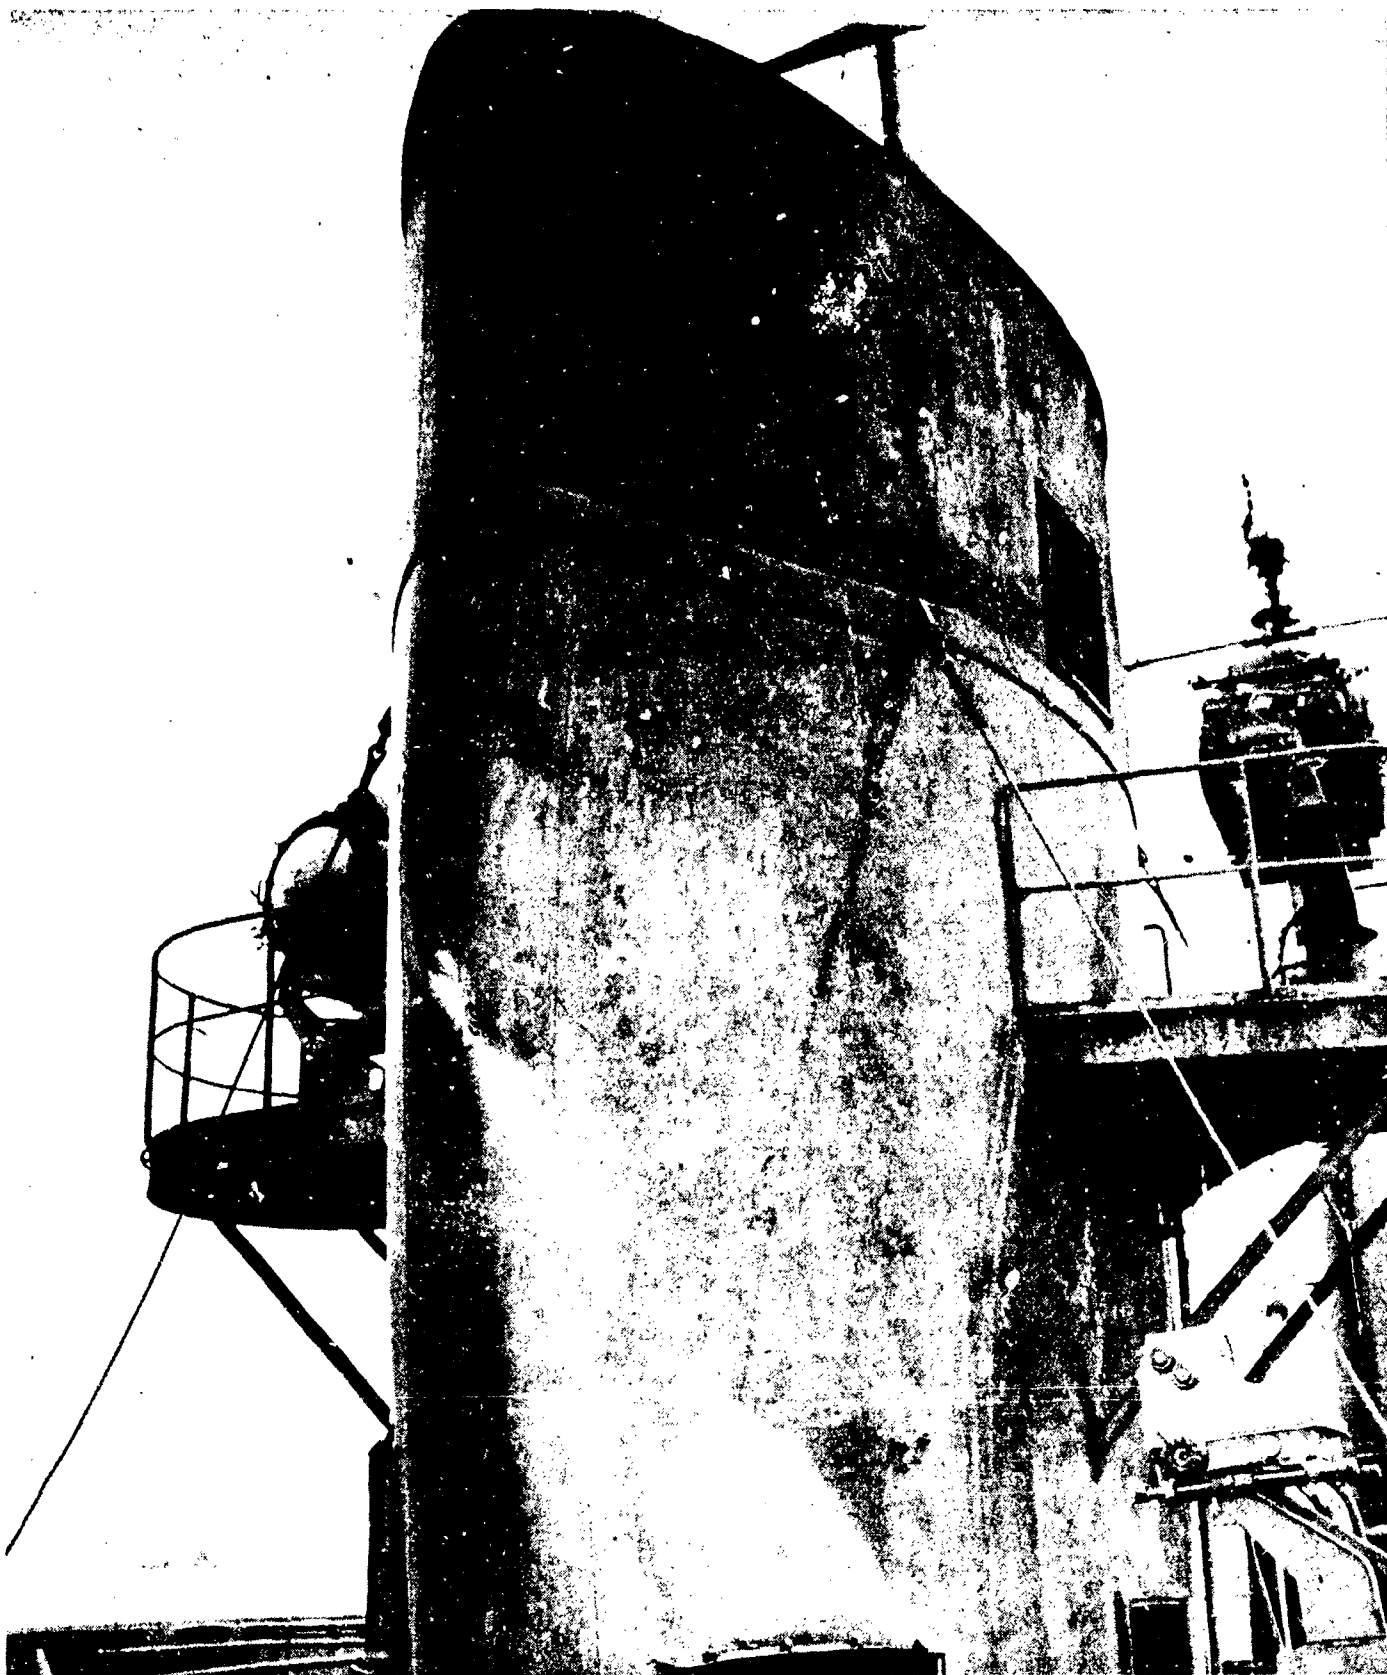
AA-CR-62-2172-12. Looking forward and to port at starboard side of forward stack. Note damaged yoke of starboard 24 inch searchlight.

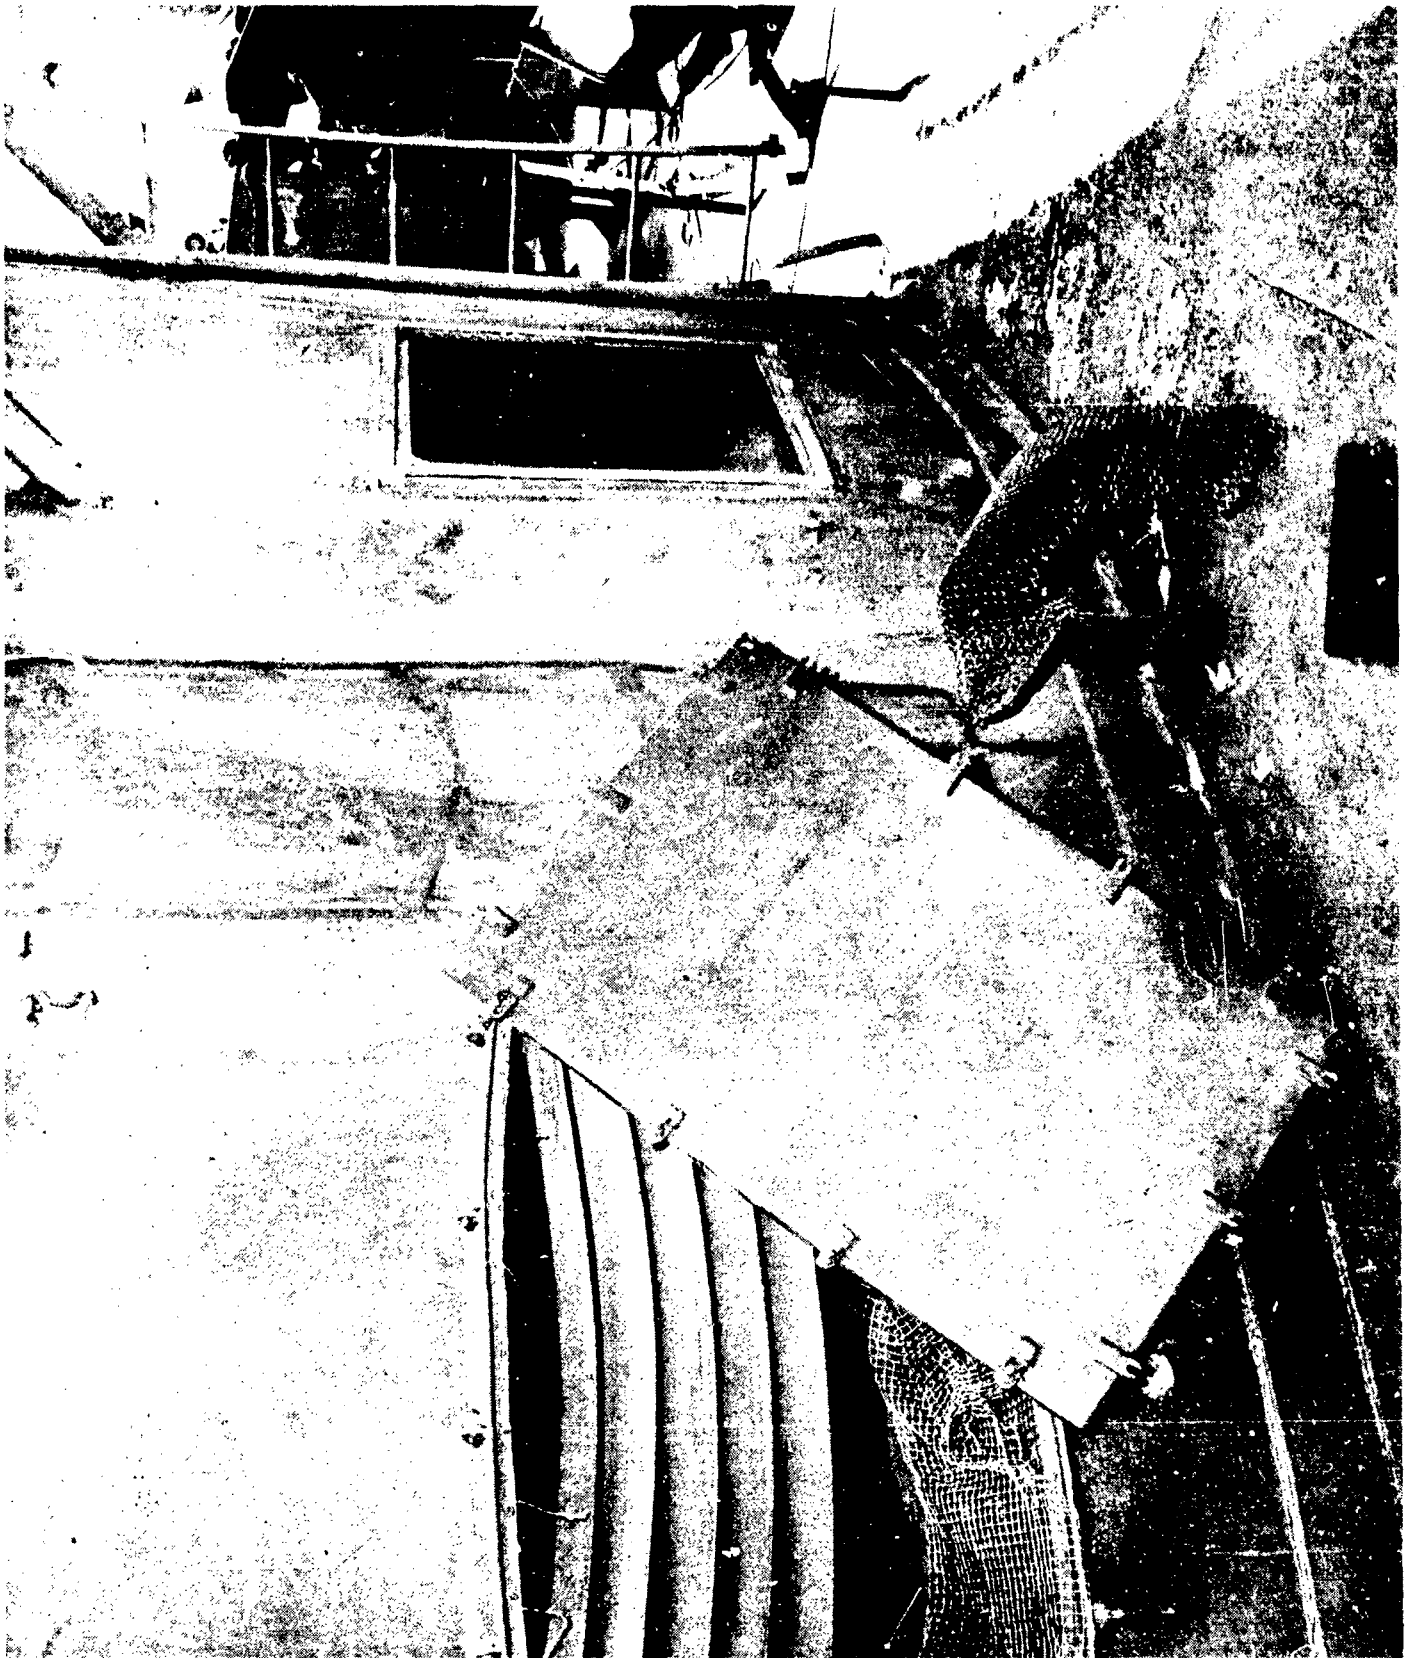
AA-CR-82-1827-3. Blast damage to vent closure on starboard side of forward stack.

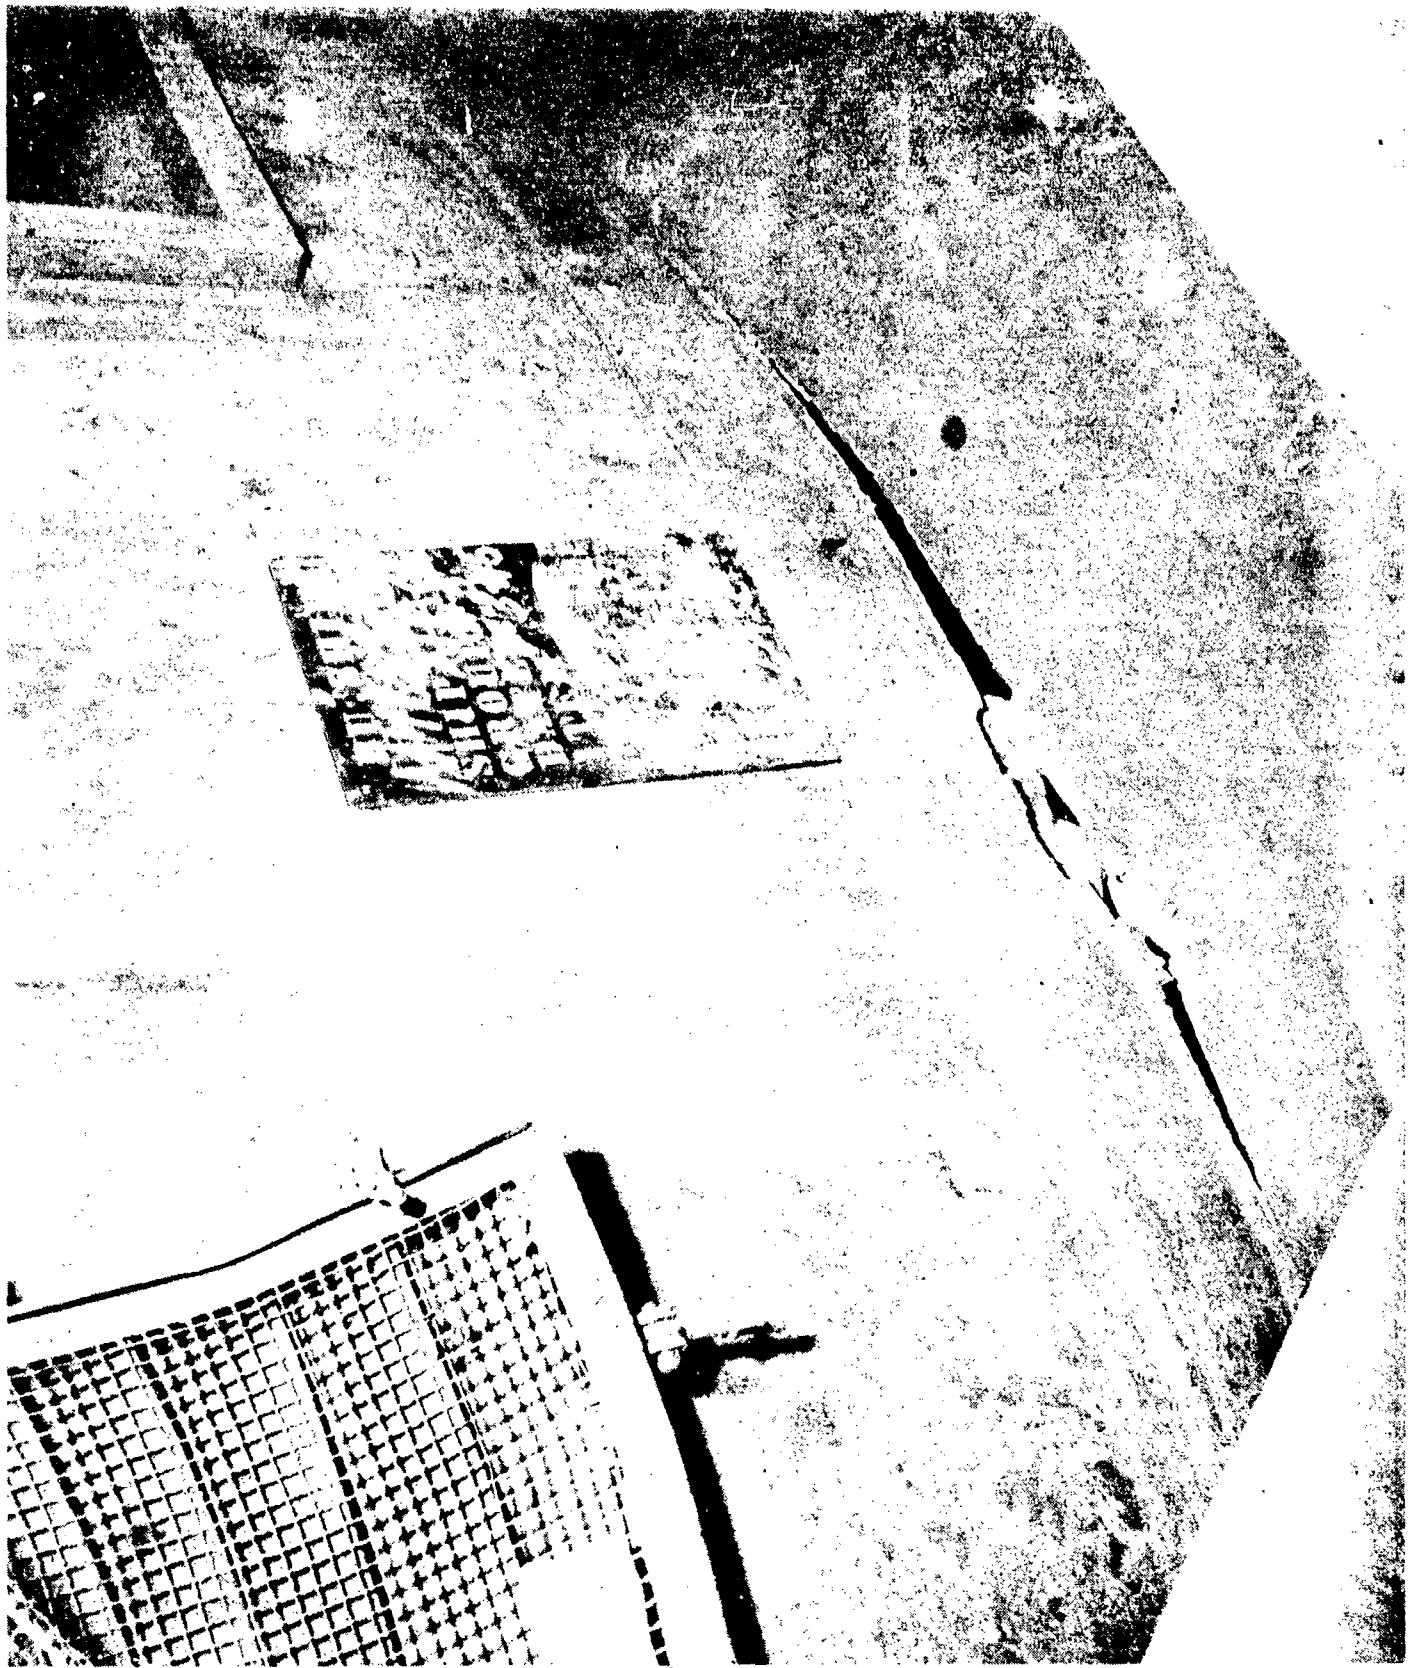
AA-CR-82-1828-4. Tear at connection of starboard side of base of after stack to top of house.

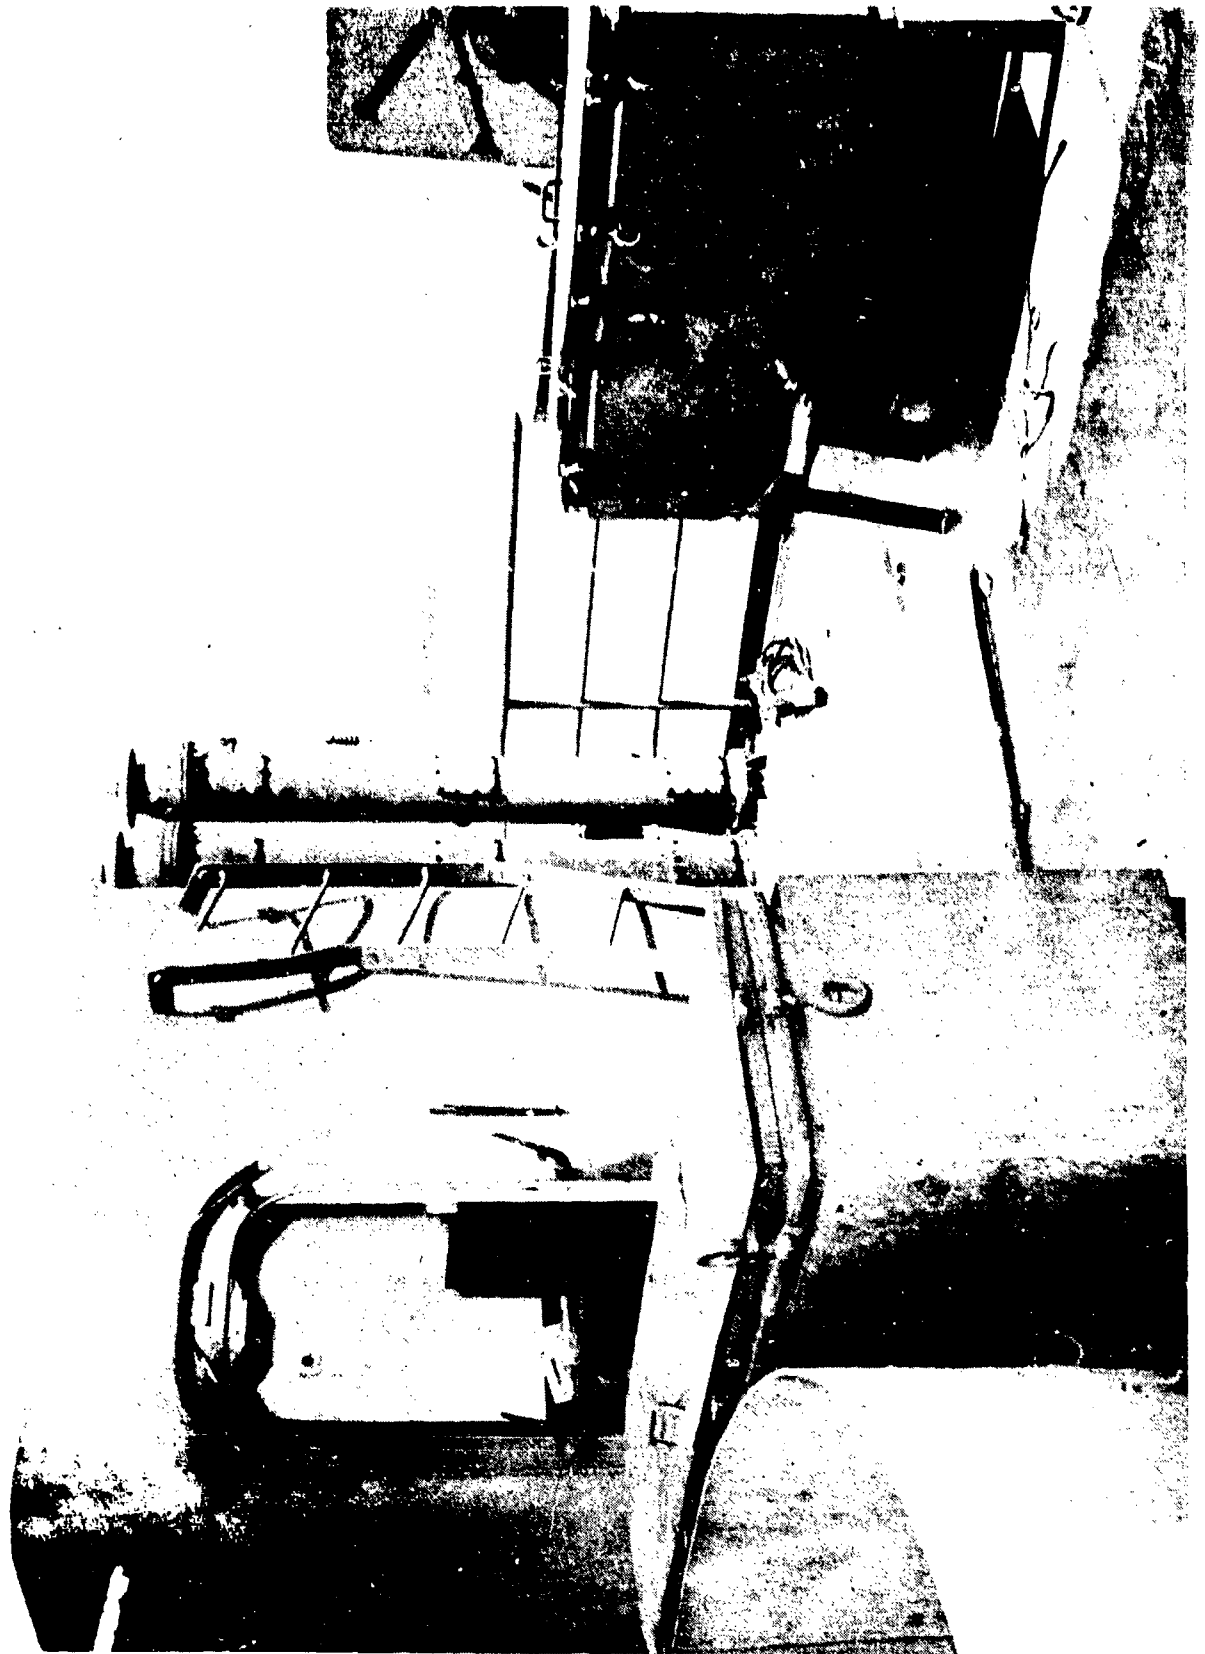
AA-CR-82-1827-4. Looking aft at forward bulkhead of RDF station showing missing door and bent ladder.

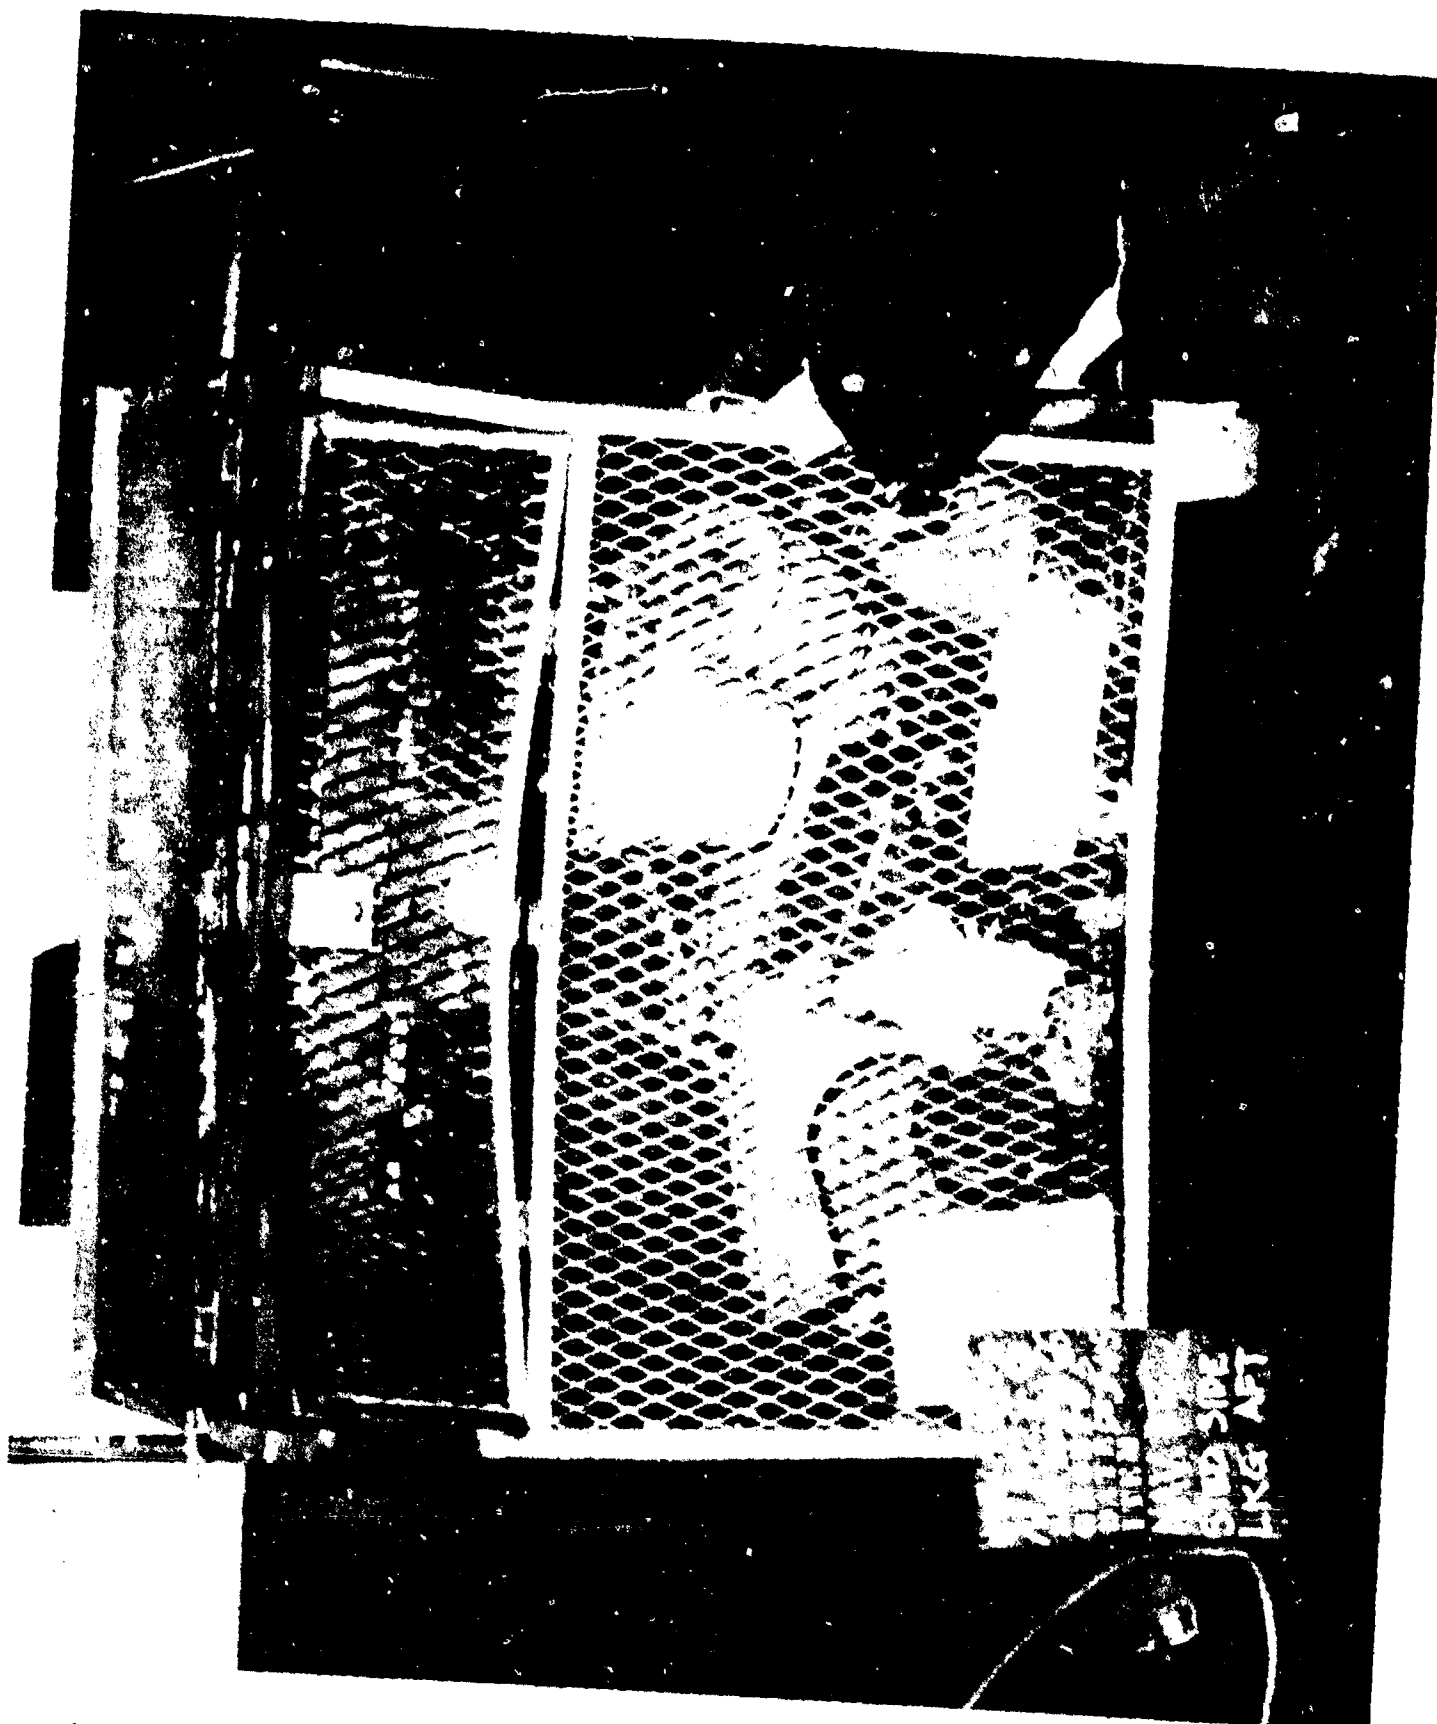
AA-CR-82-1828-6. Looking aft at blast damage to gear locker on starboard wing of navigation deck, frame 66.

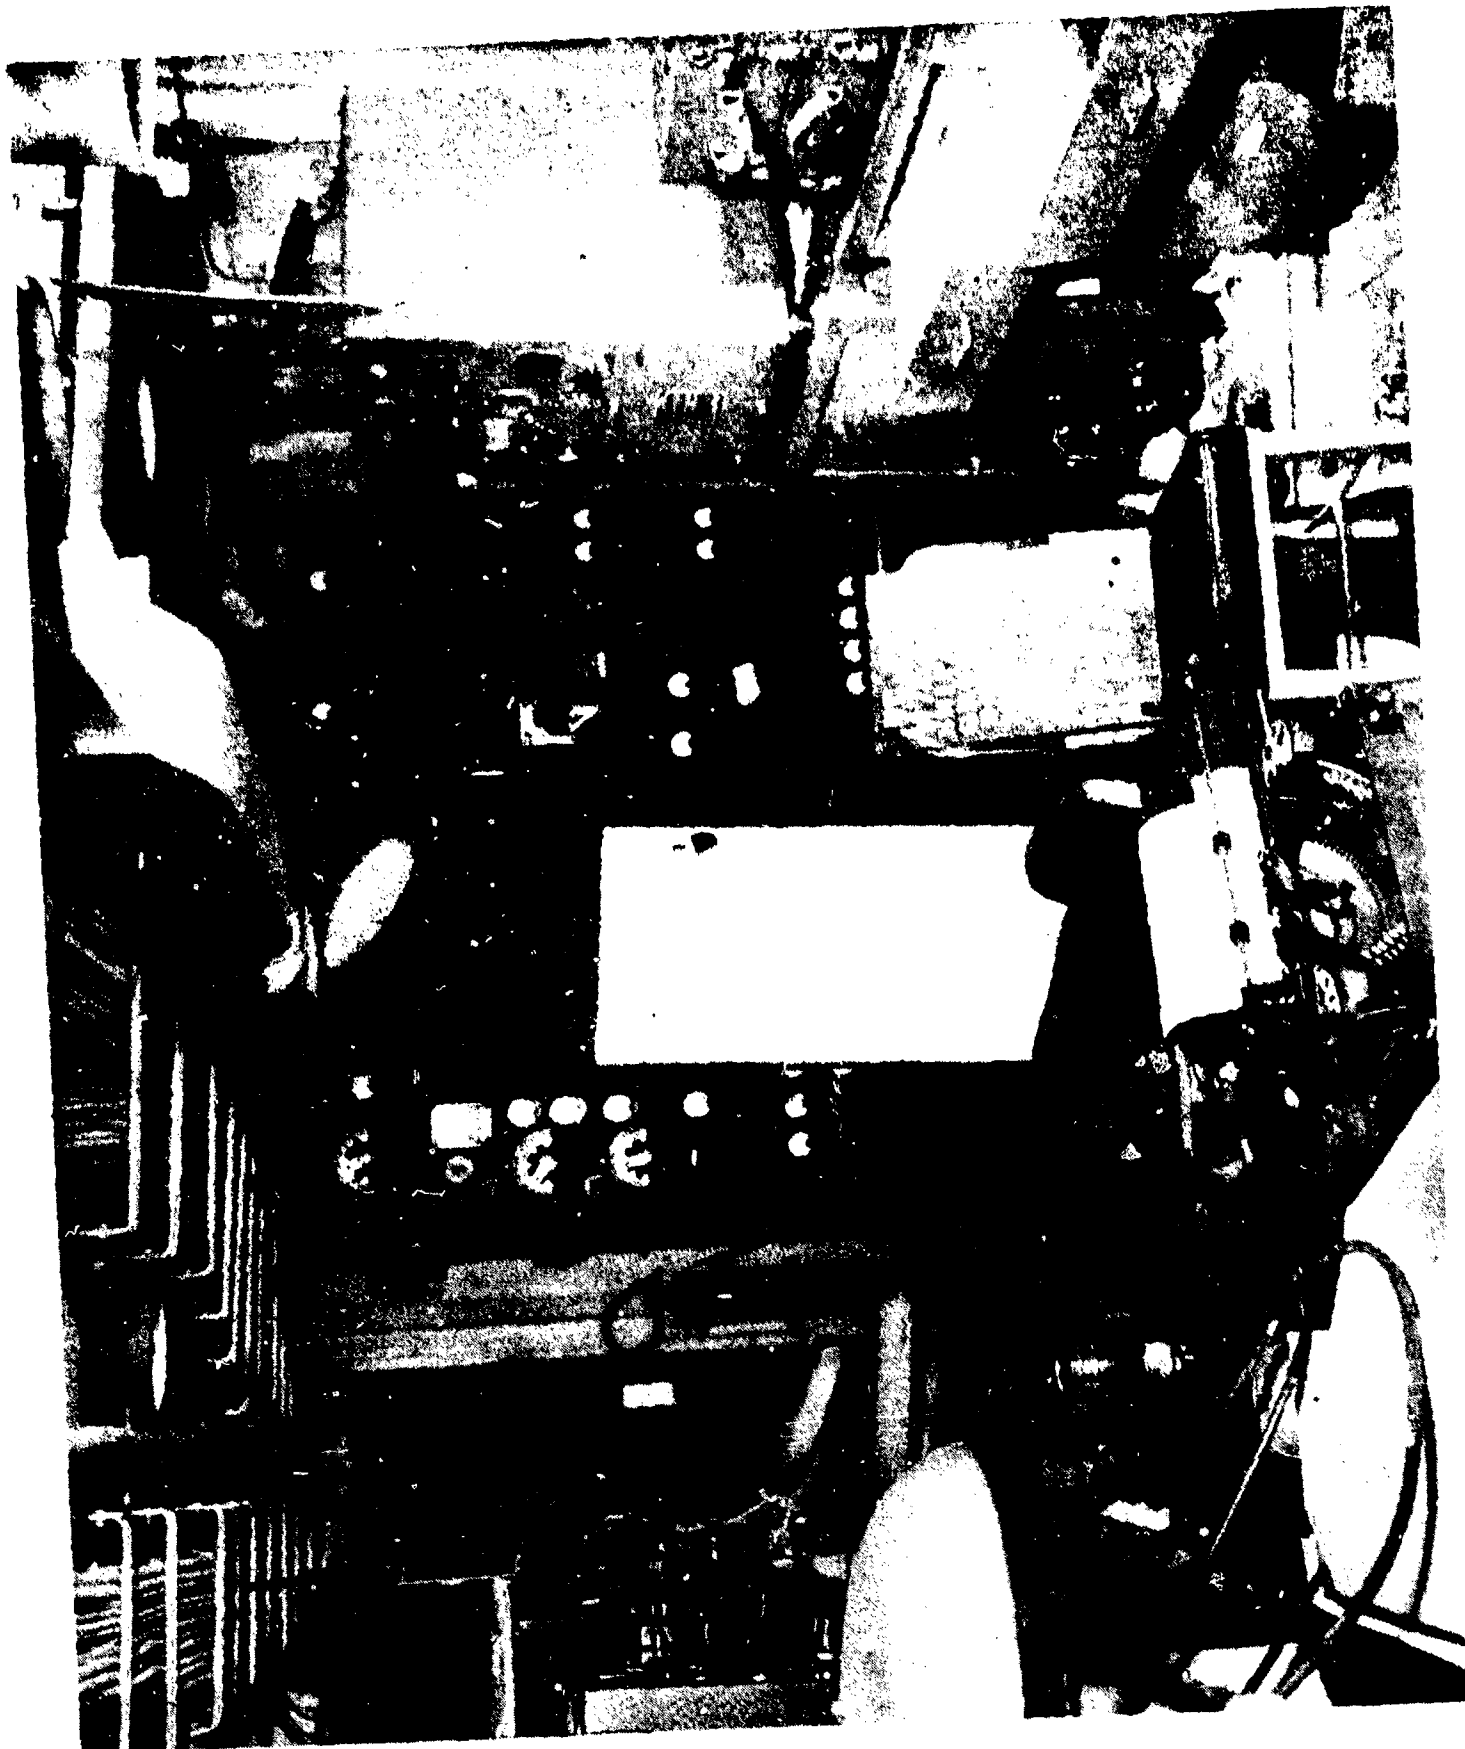
AA-CR-82-1828-2. Looking aft at disarrangement of equipment in radio 1.
